# Accelerated Corrosion Analysis of Nonchromate Conversion Coatings on Aluminum Alloys 5083, 7039, and 6061 for DOD Applications

ARL-TR-2562

August 2001

# Army Research Laboratory

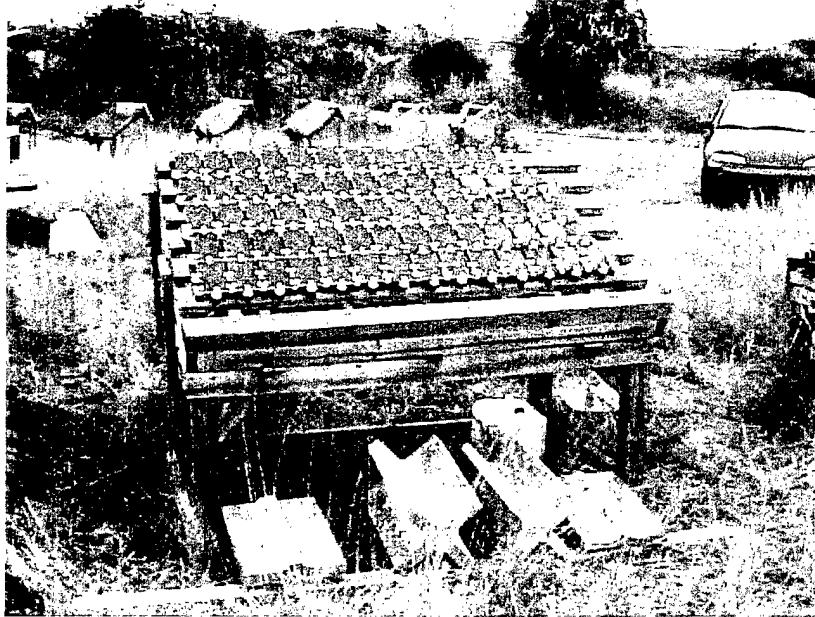
Figure 2. Aluminum armor test panels at Cape Canaveral outdoor exposure site.

Outdoor exposure was initiated on two panels of each conversion coating at the outdoor test site located at Cape Canaveral, FL (Figure 2). Long-term performance data will be obtained and presented at future Bradley EMT meetings and published in subsequent ARL Technical Reports.
